"Owl 08" – The Story of Capt. James Steadman, USAF • Capt. Robert Beutel, USAF 497th Tactical Fighter Squadron "Nite Owls" 8th Tactical Fighter Wing • Ubon RTAFB, Thailand November 26, 1971

Foreword

1. Methodology and Definitions

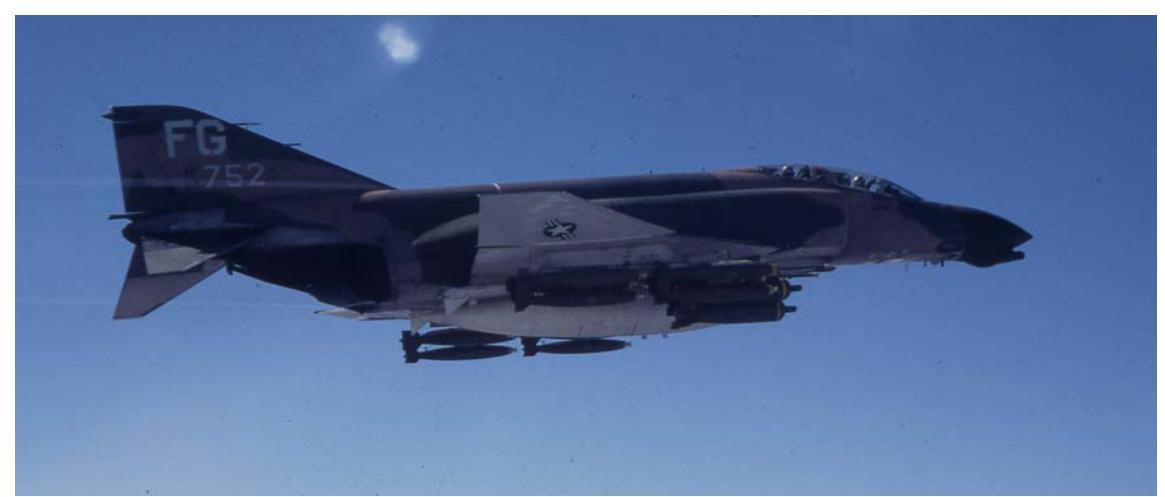
The picture above shows the missing aircraft - F-4D, 66-7752 - circa 1969 in the markings of the 433 TFS. There are at least 4 things that could be used to uniquely identify a crash site as being Owl 08.

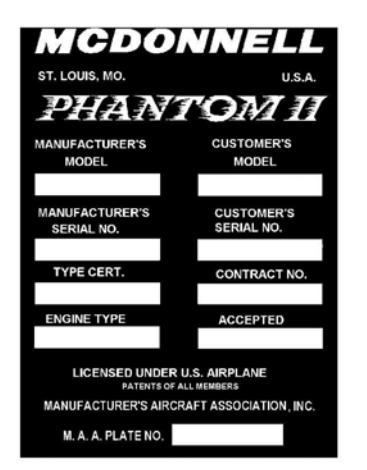
- 1. Aircraft identification plate a plate (left) with airframe serial number data can be found in the forward cockpit of every F-4.
- 2. Engine serial numbers 66-7752 was powered by two General Electric J-79-15 engines, serial numbers 439886 and 439963. Engines carry numbered dataplates (below) that can be used to uniquely identify an aircraft by tail number. Likewise, it may be possible to use turbine blades to identify engine subtype and therefore, aircraft type; JPAC messages contain references to at least one case being resolved by turbine blade analysis.

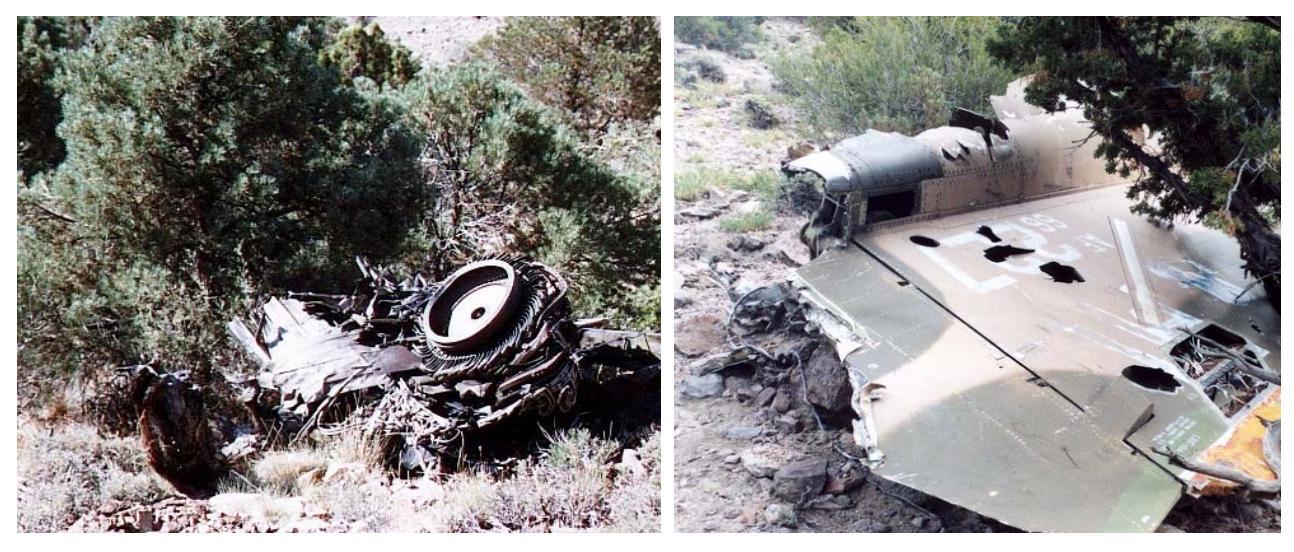
As an final point, it is reasonable to ask, "Could wreckage from 35+ years ago still be useful in identifying a particular aircraft?" The photographs below were taken in 1999 of an F-4D that crashed near Nellis AFB, Nevada in 1979. While this crash site was in a desert, engine wreckage, due to the fact it's made of stainless steel and titanium, can remain intact for long periods of time

as the photograph on the left shows. Likewise, the photo on the right shows the vertical stabilizer (tail) section, made mostly of aluminum, which does not rust.

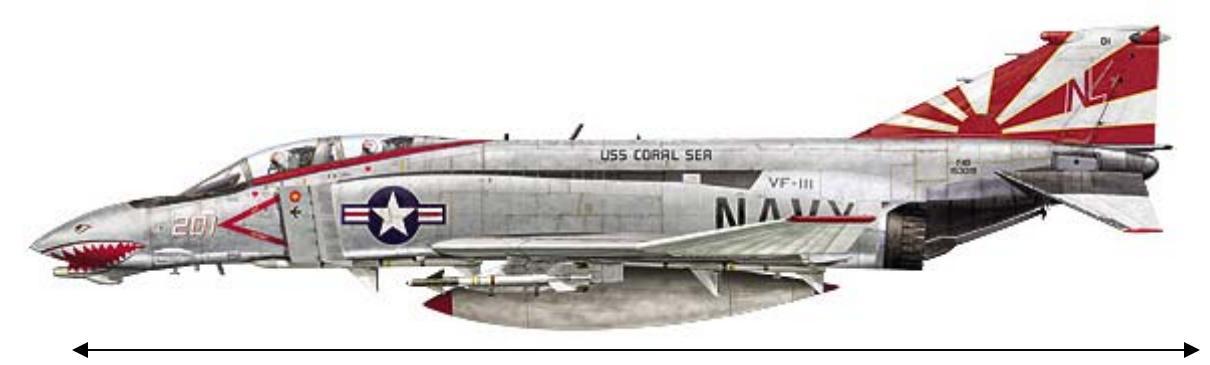
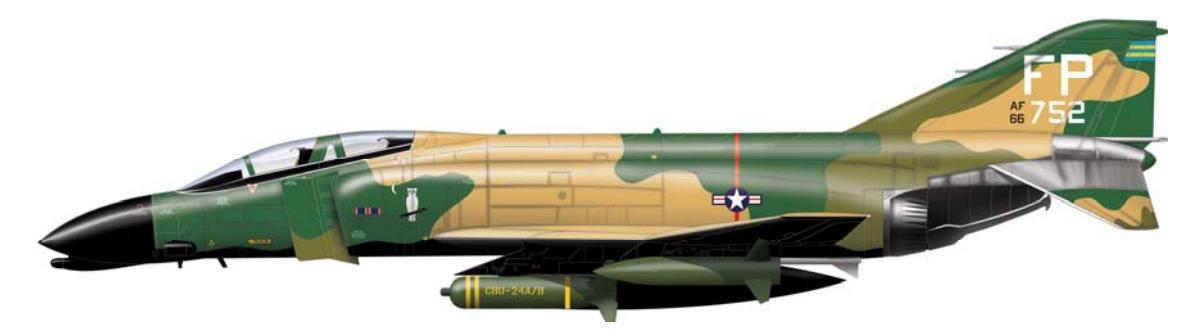
F-4 Series Differences

US Navy F-4B

US Air Force F-4D 66-7752 (this is what missing aircraft looked like the night it was lost)

The F-4B was the first production model of the Phantom family and 649 were built between 1961 and 1964, all of which were delivered to the Navy or Marine Corps. The F-4J was an improved F-4B with a different radar and more powerful engines; 522 were built between 1966 and 1972 and all were delivered to the Navy or Marine Corps. The F-4D was the second production model built to Air Force specifications (after the F-4C) and 793 were built between 1965 and 1968; nearly all were delivered to the Air Force.

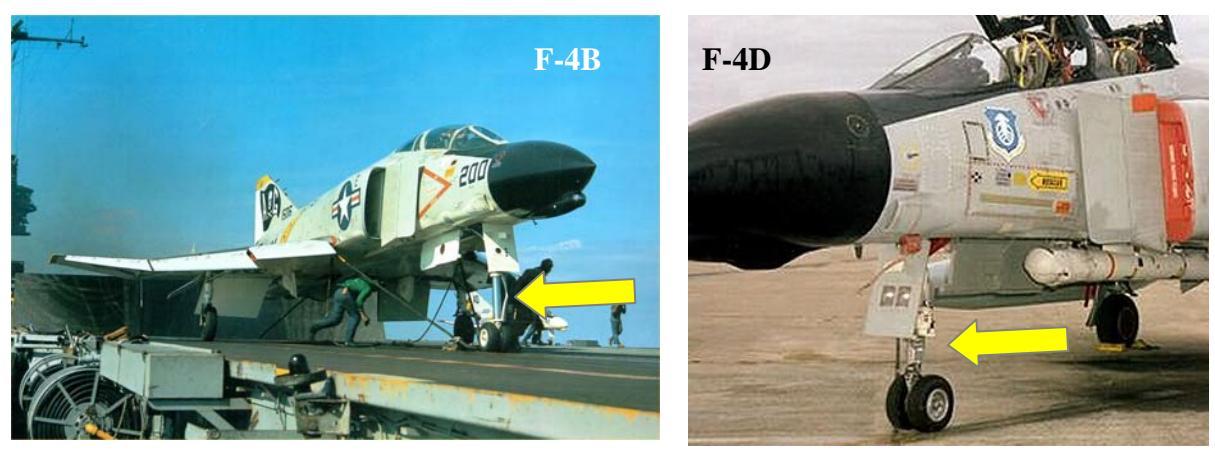
• All Navy F-4s had an extensible nosegear (left) that gave the aircraft added lift for carrier launches. F-4Ds (right) did not have (or need) such a thing.

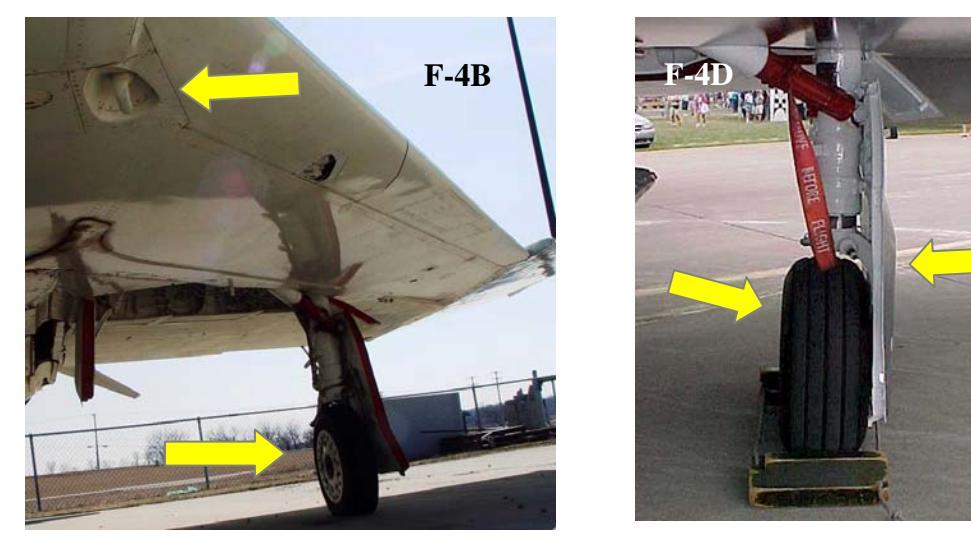
All Navy F-4s (left) had attachment points for carrier launches and F-4Bs had thin tires (for landing on decks). F-4Ds (right) lacked attachment points and had thicker tires (for runway operations), whose extra width required landing gear doors to bulge outward slightly (F-4Js also had thick tires).

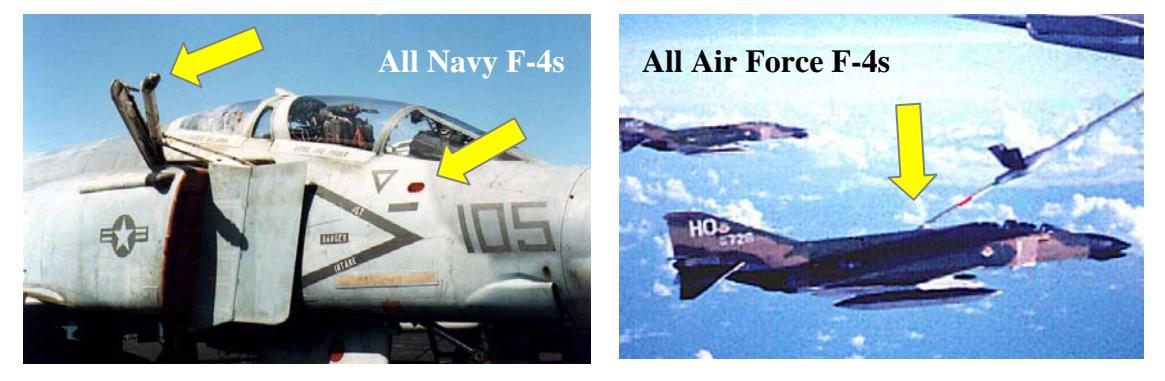
All Navy Phantoms (left) had a refueling probe on the right side of the fuselage as well as a small red light under the windshield to help the pilot see during night refueling. All Air Force F-4s (right) had a refueling receptacle on the spine of the aircraft.

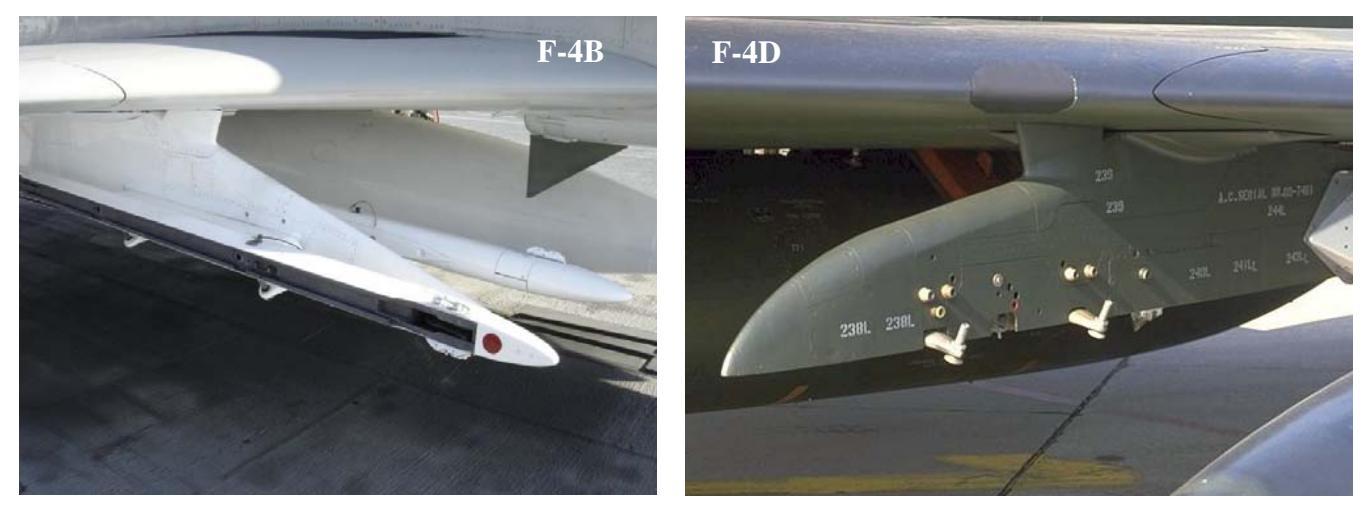
All Navy Phantoms had pointed-style inboard weapons pylons (left) versus curved ones (right) found on all F-4Ds (and nearly all Air Force Phantoms).

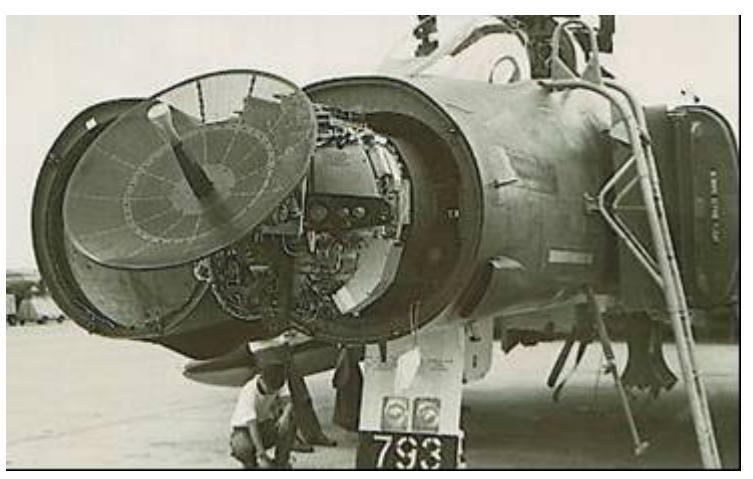
The F-4D was equipped with a Westinghouse APQ-109 radar (right) that could track airborne targets and guide Sparrow air-to-air missiles or, map ground targets and release bombs. It was used in conjunction with the Weapons Release Computer Set (WRCS, pronounced "W-R-C-S") to deliver air-to-ground weapons.

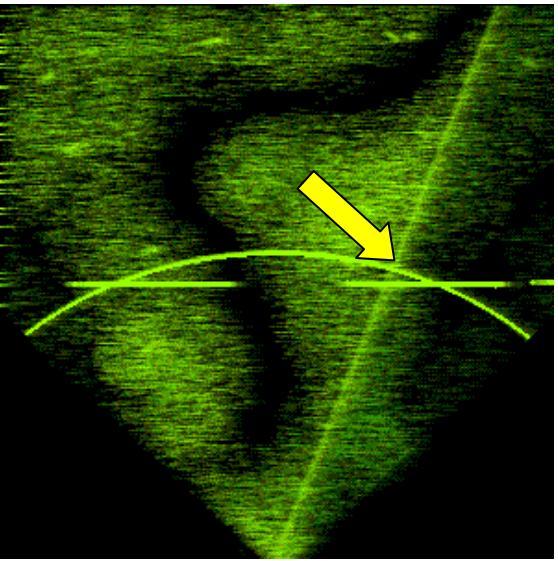
The image (right) shows the display of an F-4D radar in ground map mode (the dark, curve-shaped area is a river). The arrow at the intersection of the two green strobes shows the radar cursor, which could be placed over an aimpoint on the ground for the purposes of navigating to it or dropping a weapon on it. The radar/WRCS combination was the primary method the 497th used to drop flares.

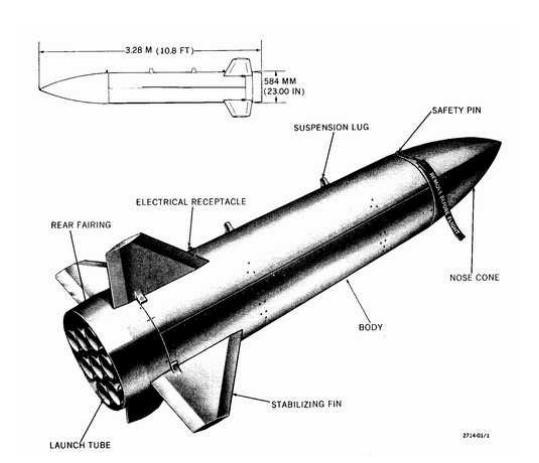
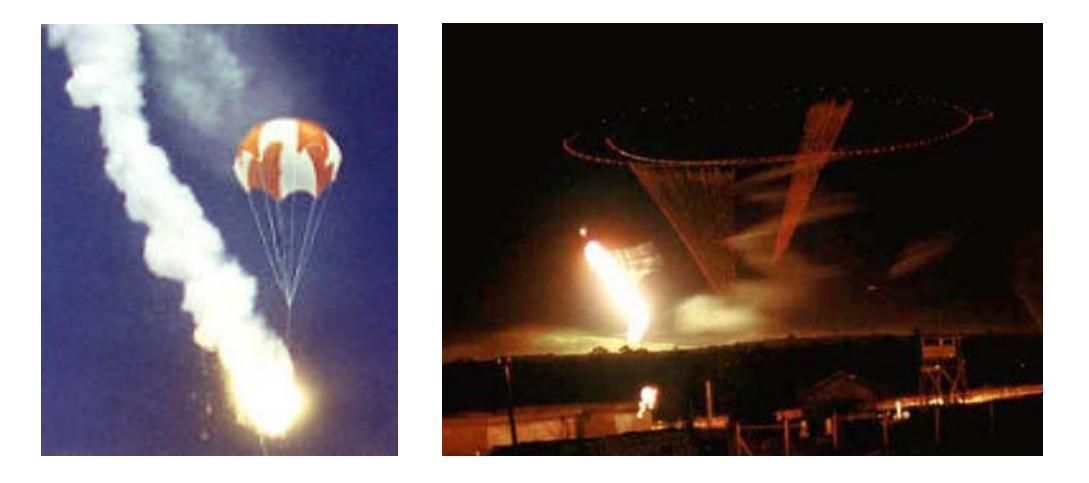
The SUU-42 (left, pronounced "sue forty-two") was a dispenser for parachute-deployed flares and was carried on the outboard weapon stations (the ones furthest out on the wings).

Before the development of night-vision devices, flares dropped by parachute, such as the LUU-2 (pronounced "Lou two"; left), were used by crews to detect and identify targets at night. LUU-2s burned for 3-5 minutes and the time-elapsed photo (right) shows a flare (white streak on the left) during a combat mission.

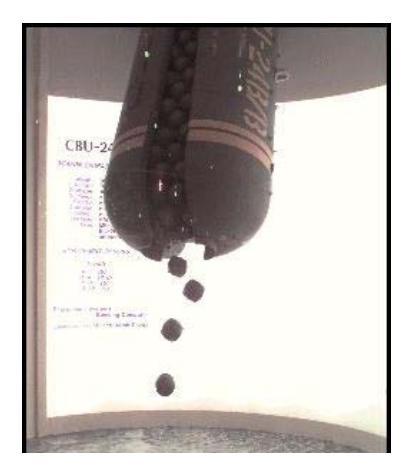
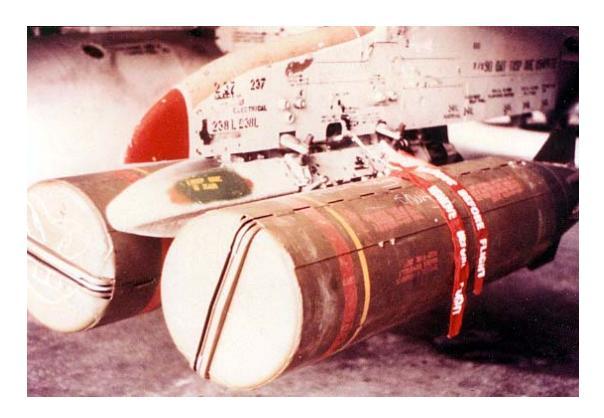
Owl 08 was carrying CBU-24 (pronounced "C-B-U twentyfour") Cluster Bombs (normal Owl FAC ordnance load was CBU-49, which is discussed later in this document) that consisted of a clamshell dispenser containing 670 BLU-26 (Bomb Live Unit, pronounced "blue-ee twenty-six") baseballsize bomblets designed for use against personnel and nonarmored vehicles. CBU-24 was an ideal weapon to use against trucks, weighed 800 pounds, and up to four would normally be carried on an F-4. The photograph to the left shows a museum display with a CBU-24 as its clamshell is opening and dispensing BLU-26 bomblets.

M36 incendiary cluster bombs (right) weighed 690 pounds, contained 182 M126 incendiary bomblets, and were also effective against trucks. M36s were left over from World War II and had blunt noses because they were designed to be carried in the internal bomb bays of B-29s.

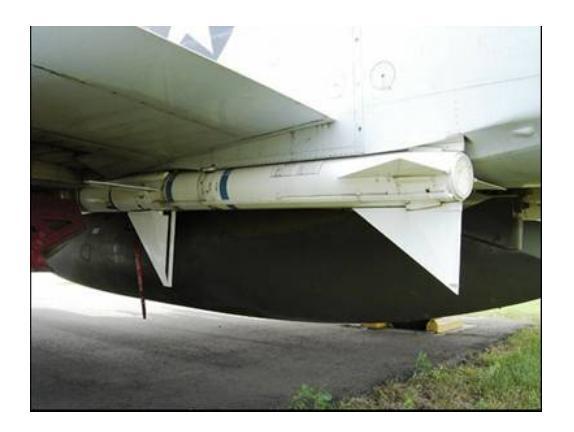
AIM-7 Sparrow radar-guided missiles (left) were the Phantom's primary air-to-air weapon and had a maximum range of 2-12 miles. Nite Owls carried them for self-defense against enemy MiG fighters (although no engagements occurred over Laos because MiGs were based too far north). Sparrows weighed 510 pounds and up to four could be carried under the fuselage, although 497th aircraft normally carried only two in the aft stations. The photograph (left) shows a Sparrow loaded in an F-4D aft station.

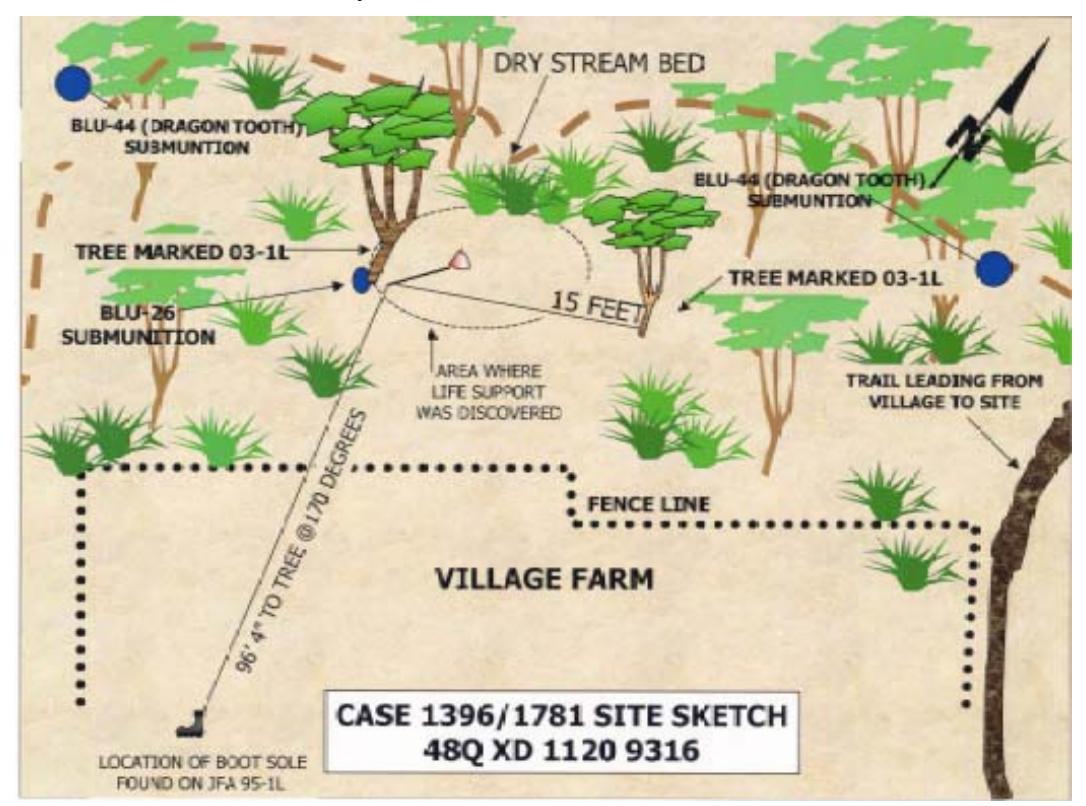
JFA sketch of "Site 3"

JPAC has ruled out all the suspected Owl 08 sites but one – "Site 3" – which means either Owl 08 crashed here or is at a yet-to-be-determined location. At this location (JPAC sketch be-low) wreckage of an undetermined F-4 model was found with BLU-26 bomblets and BLU-44 anti-personnel mines in the vicinity.

While Owl 08 was carrying almost 2,000 BLU-26s in its 3 CBU-24s, it was not carrying any BLU-44s. In fact, the 497th never carried BLU-44s, which were sometimes dropped along with sensors on the Ho Chi Minh Trail as part of the highly-classified "Igloo White" program. The

At first glance, the presence of BLU-44s at this site might appear to rule it out as being Owl 08. However, since both BLU-26s and BLU-44s were ubiquitous in Eastern Laos, it may be both are coincidental with the aircraft wreckage; that is, an F-4 may have crashed in area where BLU-26s and BLU-44s had already been dropped. Since BLU-44s do not explode on contact with the ground and CBU have a 5-20% dud rate, there are likely many thousands of unexploded BLU-26/44s in the Ban Karai area, which may account for the discrepancy. While JPAC says there are no known F-4s lost in this area while carrying BLU-44s, their presence does not rule out this site as Owl 08. The photo below shows an 8 TFW F-4D over the "Dog's Head", a prominent landmark near Ban Karai. It clearly shows the results of Nite Owl interdiction missions on the Ho Chi Minh Trail and dense concentrations of bomb craters are clearly visible. One can easily imagine the amount of unexploded of ordnance still there today.

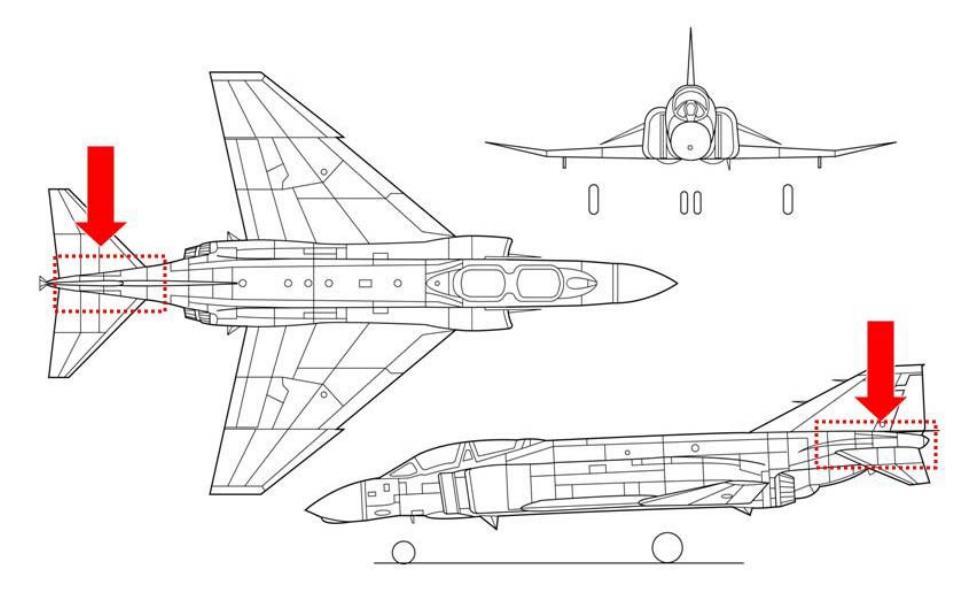
In November 2002 during the 76th JFA, a JPAC Team discovered and photographed wreckage found at "Site 3" that is from an F-4 series aircraft. The wreckage is from the tail section as shown by the arrows in the image below.

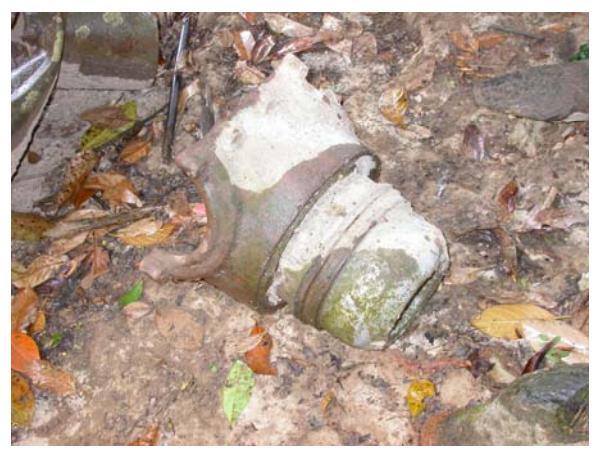
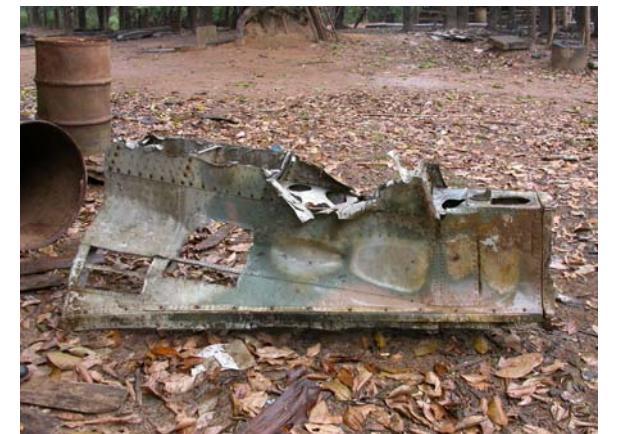
This piece of wreckage is an actuator that This piece is part of an F-4 aft fuselage. moved the tail section control surfaces.

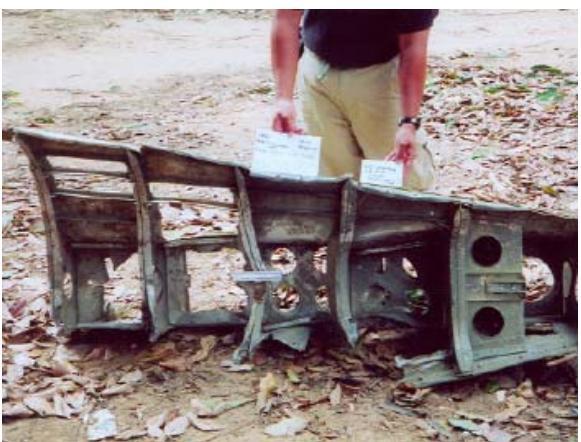
The is the last 6 feet of an F-4 fuselage; the identification plate in the next image was found here.

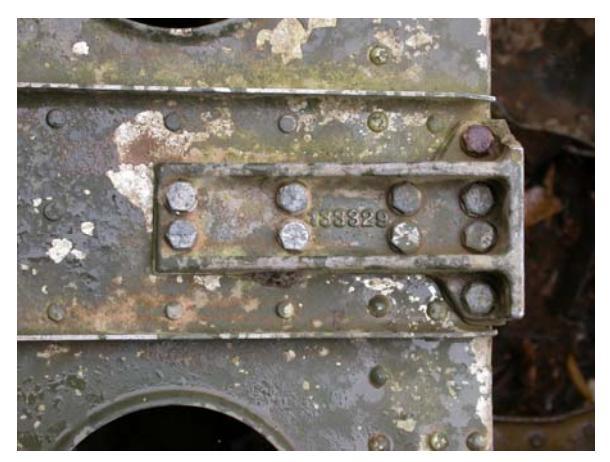
Close-up of the identification plate.

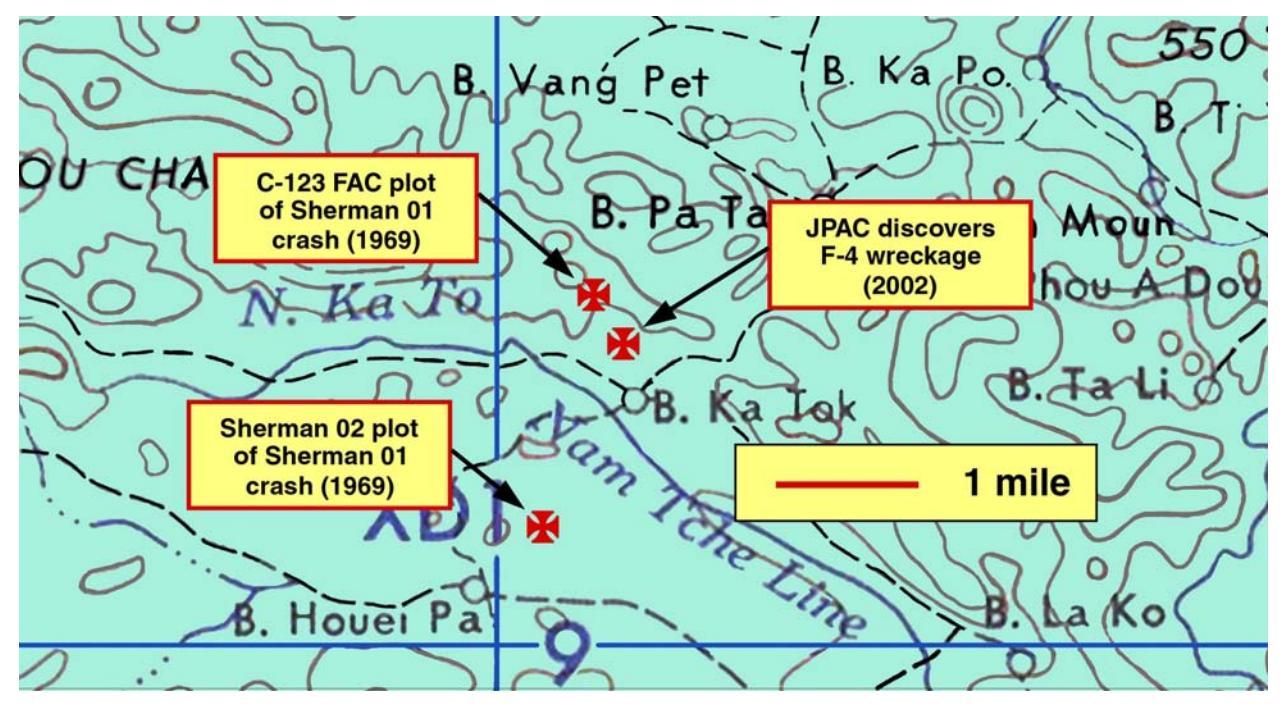
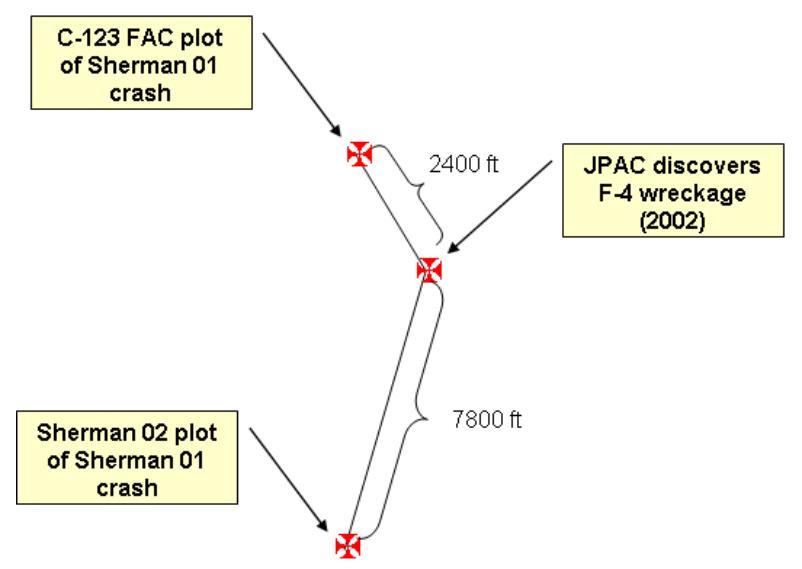
Two years before Owl 08 went missing, Maj Wendell Keller and 1Lt Virgil Meroney (Case 1396) went missing in an F-4D (callsign Sherman 01) in the Ban Karai area. There were multiple eyewitnesses to this crash – the wingman (Sherman 02, interviewed as part of case research) and the crew of a C-123 cargo aircraft operating as the airborne FAC. Using charts of Laos and mapping software, the author created the image below that shows the positions where the eyewitnesses saw Sherman 01 crash relative to where the wreckage at "Site 3" was found.

Stripping away the map image, you can see the C-123 FAC plotted the crash only 2,400 feet from where the wreckage was found in 2002. While this might not seem accurate given modern standards, a plot of this accuracy made during combat night with the navigational aids of 40 years ago is quite precise. Likewise, the author interviewed the wingman pilot who said the FAC's plot would have been more accurate.

Additionally, both eyewitnesses stated Sherman 01 impacted the ground at a steep angle, which is consistent with the wreckage found (the only large pieces came from the tail section). This

additional evidence says the wreckage found in 2002 belongs to Sherman 01, not Owl 08, which means Owl 08's resting place likely has yet to be found.

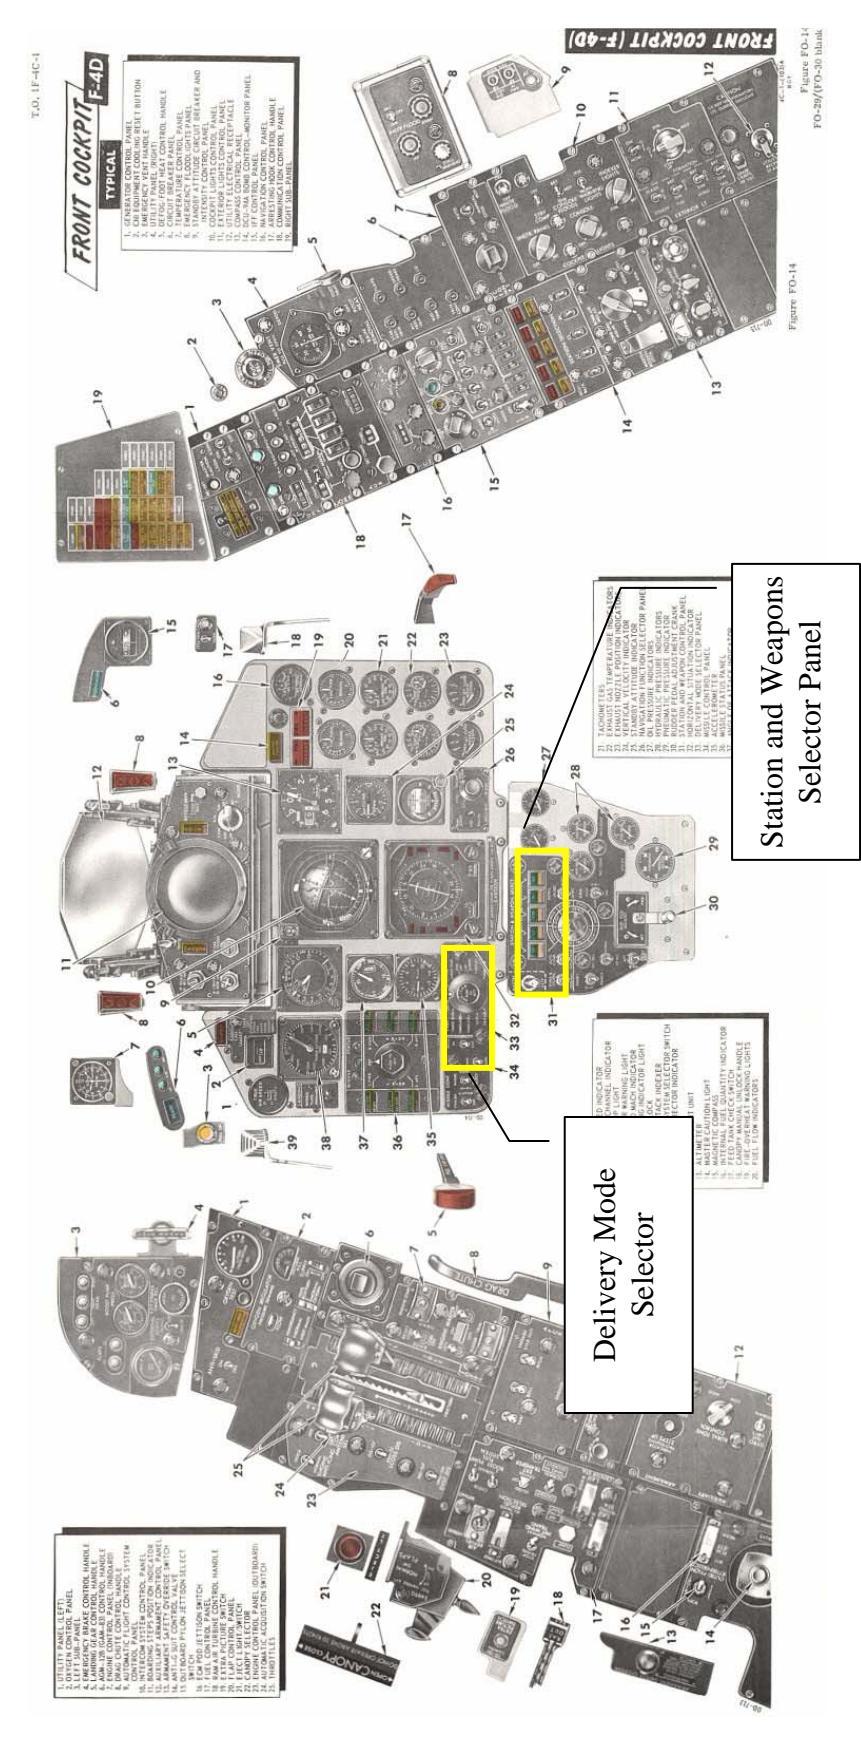
¹ Offset Bomb was the F-4D bombing mode that permitted release of conventional weapons from a level delivery without having to see the target. Capt. Steadman would have selected "Offset Bomb" on the Delivery Mode Selector Panel (highlighted below, left) and then selected the outboard weapons stations (the ones furthest out on the wings, which carried the flare dispensers) on the Station and Weapon Select Panel (highlighted below, center).

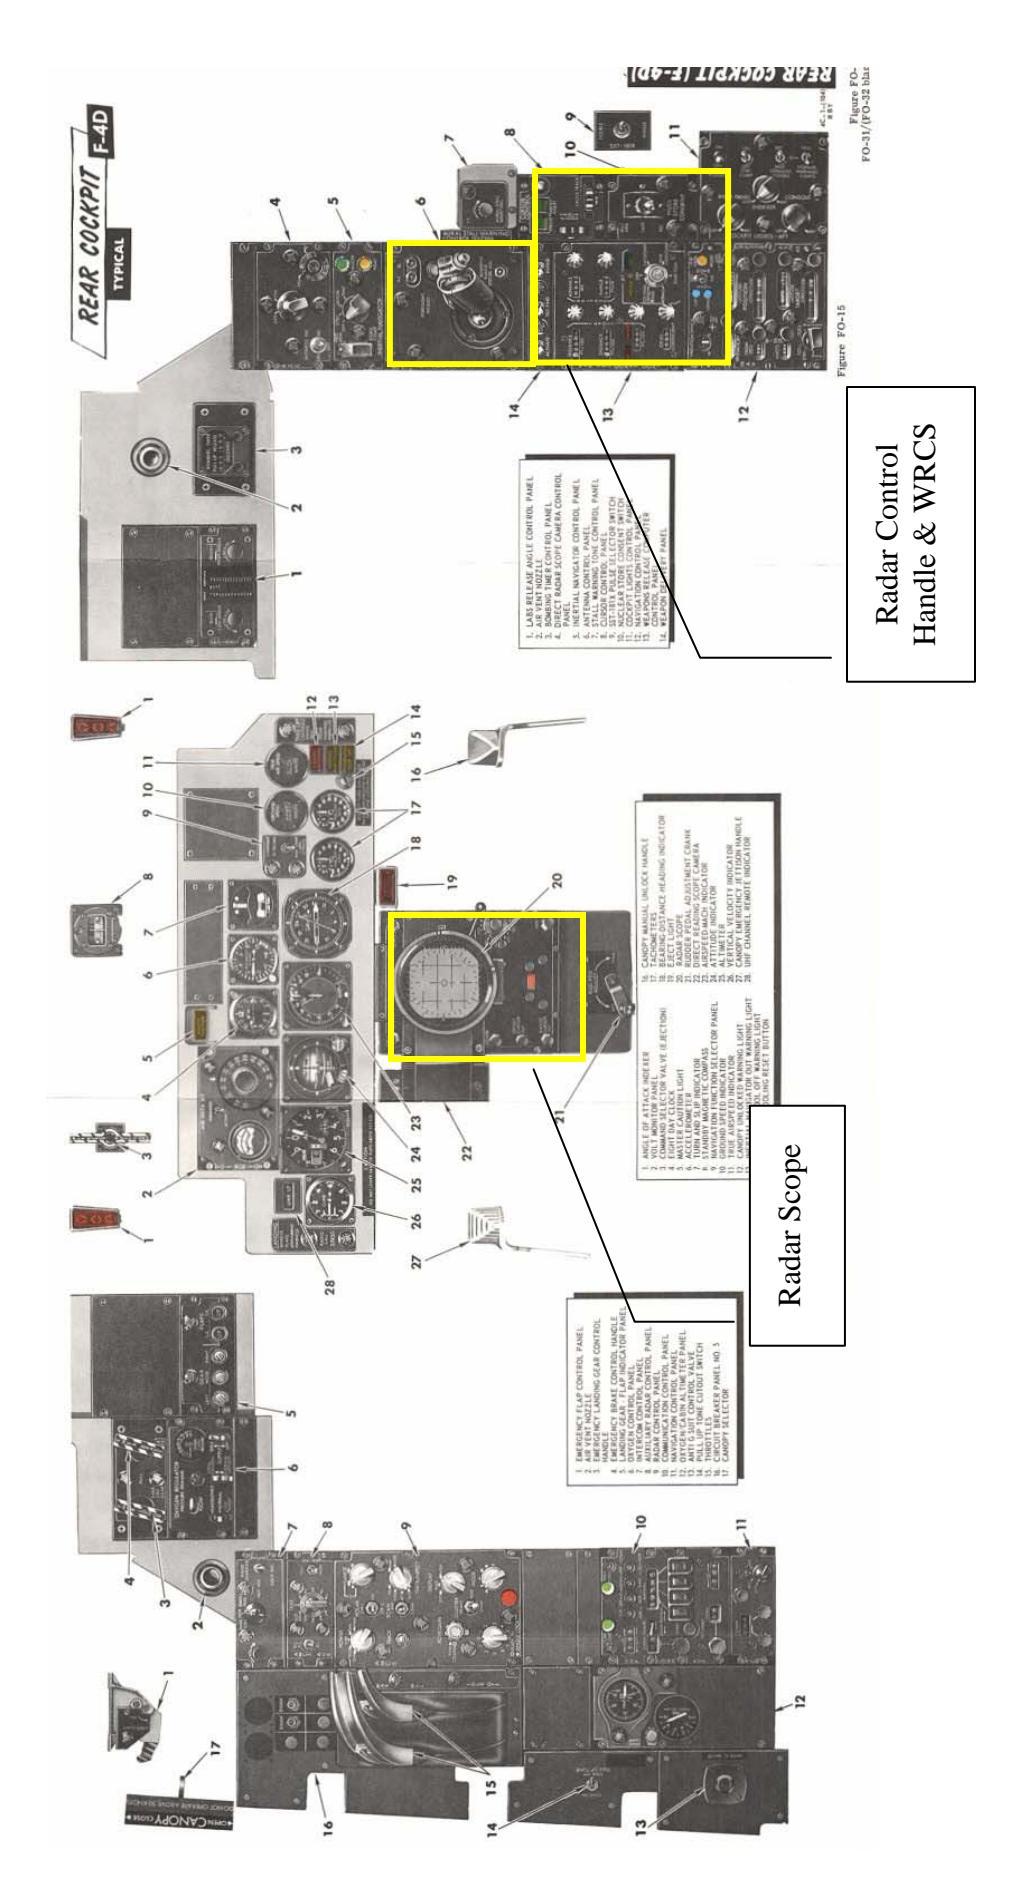
² 1Lt Beutel would have located an offset aimpoint using the radar scope (highlighted below, center) and using the radar control handle (highlighted below, top right), would have placed the cursor over the aimpoint. He would have previously entered distance and weapons data into the WRCS (highlighted below, bottom right), which would then take radar data, calculate a release point, and automatically release the flare.
